John Day Watershed Restoration Projects

**Annual Report
2001 - 2002**

FY 2002 Watershed Restoration Projects

Project Number: 98-018-00

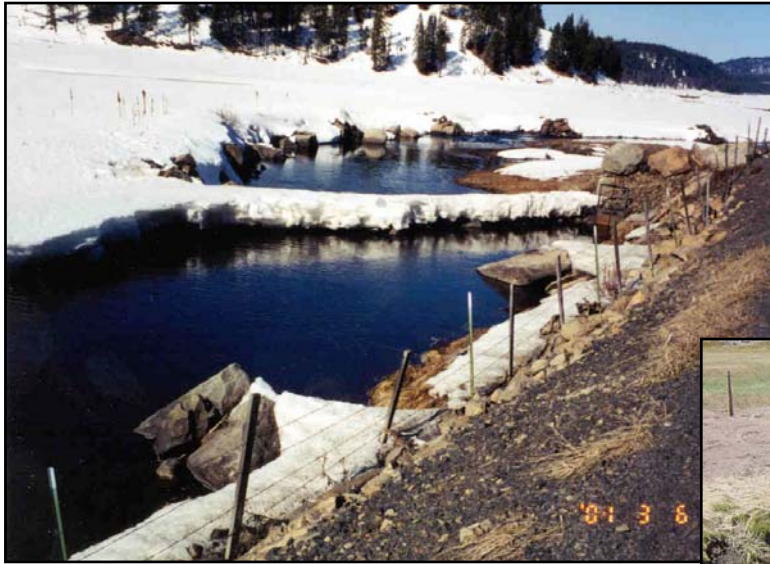
Photo 1. Pre-project photo of the Forrest Middle Fork # 1 Diversion site.

Project Background: Irrigation water on the Forrest Conservation property historically has been diverted by a gravel and rock push-up diversion, which directed water through an open canal.

1. Input and analyze data collected under the 2001 monitoring plan for the project site.
2. Complete the engineering survey and design layout.
3. Replace annually installed push-up diversion with a permanent lay flat diversion.
4. Remove existing Corrugated Metal Pipe (CMP) and enlarge conveyance ditch to blend with down stream ditch.
5. Install a water use measuring device.
6. Utilize existing fish screen.
7. Rebuild fences removed or damaged during construction.
8. Plant grasses and hardwoods on both banks to increase rates of recovery.

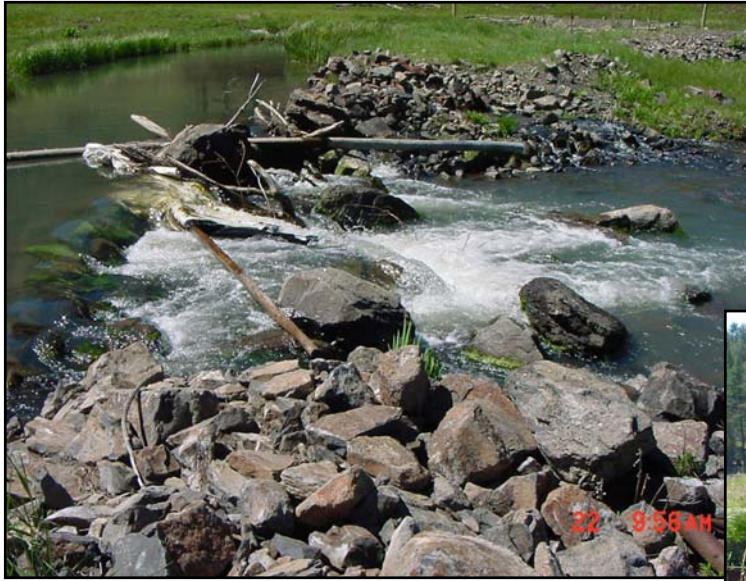
Photo 3. Pre-project photograph of Forrest Middle Fork Diversion #2

Project Background: Irrigation water on the Forrest Conservation property historically has been diverted by a gravel and rock push-up diversion, which directed water through an open canal.

1. Input and analyze data collected under the 2001 monitoring plan for the project site.
2. Complete the engineering survey and design layout.
3. Replace annually installed push-up diversion with a permanent lay flat diversion.
4. Install PVC pipe to connect existing open irrigation conveyance system to new diversion.
5. Install a water use measuring device.
6. Use existing Fish Screen.
7. Rebuild fences removed or damaged during construction.
8. Plant grasses and hardwoods on both banks to increase rates of recovery.

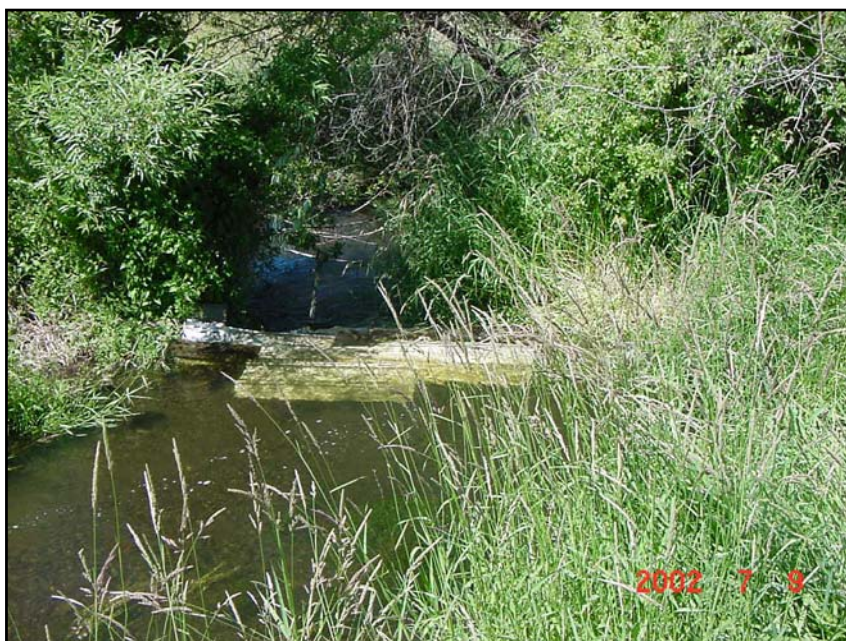
Photo 5. Rice diversion, pre-construction

Project Background: Historically the Vidondo/Ricco Ranch has diverted water for irrigation by the use of annually installed gravel and rock push-up dams many of which had old car bodies used to support the structures. This project involved the installation of a permanent lay-flat diversion to replace the temporary push-up diversion. Removing the push-up diversion allows unrestricted fish passage at all river levels, reduced sediment input, halts streambed/streambank degradation, and allows the aquatic and terrestrial system to recover. These projects are located east of Prairie City on the Mainstem John Day River within critical habitat for Chinook, steelhead and bull trout.

1. Input and analyze data collected under the 2001 monitoring plan for the project site.
2. Complete the engineering survey and design layout.
3. Replace annually installed push-up diversion with a permanent lay-flat diversion.
4. Install new head gate.
5. Install measurement flume.
6. Install CMP to connect new diversion to existing conveyance system.
7. Install new fish screen.
8. Fill old ditch from old diversion site to allow for new diversion ditch.
9. Rebuild fences removed during construction.
10. Plant grasses and hardwoods on both banks to increase rates of recovery.

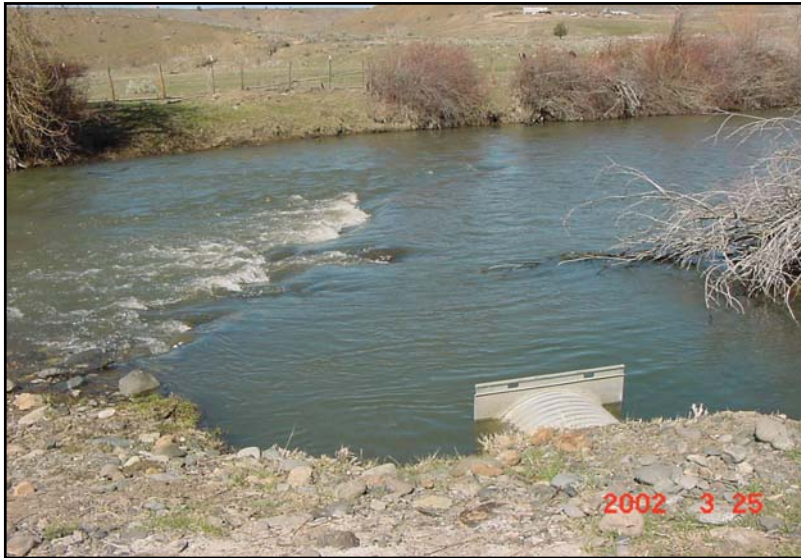
Photo 11. Walker Diversion pre-construction

Project Background; Water for irrigation on at the Walker diversion site has historically employed the use of a temporary push-up diversion. To replace this diversion an infiltration gallery was installed at the site and connected to the existing mainline. The project is located near the city of Mt. Vernon on the Mainstem John Day River. Removing the push-up diversion allows unrestricted fish passage at all river levels, reduced sediment input, halts streambed/streambank degradation, and allows the aquatic and terrestrial system to recover.

1. Input and analyze data collected under the 2001 monitoring plan for the project site.
2. Complete the engineering survey and design layout.
3. Replace annually installed push-up diversion with infiltration gallery.
4. Install pressure pump and valve system.
5. Install PVC pipe to connect existing open irrigation conveyance system to new diversion process.
6. Install measuring device.
7. Rebuild fences removed during construction.
8. Plant grasses and hardwoods on bank to increase rates of recovery.

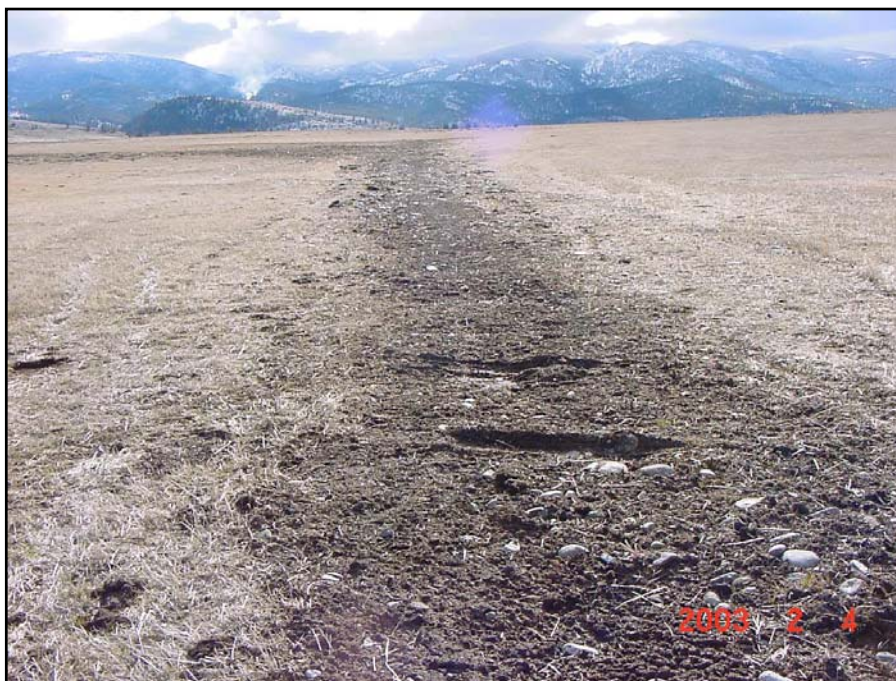
Photo 13. Holliday Return Flow Cooling #4 South Post Installation.

Project Background; Water returning from irrigation usage to the stream channel increases in temperature due to solar radiation. Our solution has been the return-flow cooling (RFC) system. The Holliday RFC #4S project area is located within migratory and rearing habitat for spring Chinook and steelhead and migratory and over-wintering habitat for bull trout and westslope cutthroat. The Return-flow Cooling #4S project replaced the open ditches with perforated PVC pipe. These pipes collect return flows below ground and transport the run-off to the river directly. Monitoring of similar projects has revealed a remarkable increase in water quality of return flows and improvements in localized water quality in the river water column following installation of such return-flow cooling systems.

1. Input and analyze data collected under the 2000 monitoring plan for the project site.
2. Complete the engineering survey and design layout.
3. Install buried perforated PVC pipe to replace existing open irrigation return system.
4. Rebuild fences removed during construction.

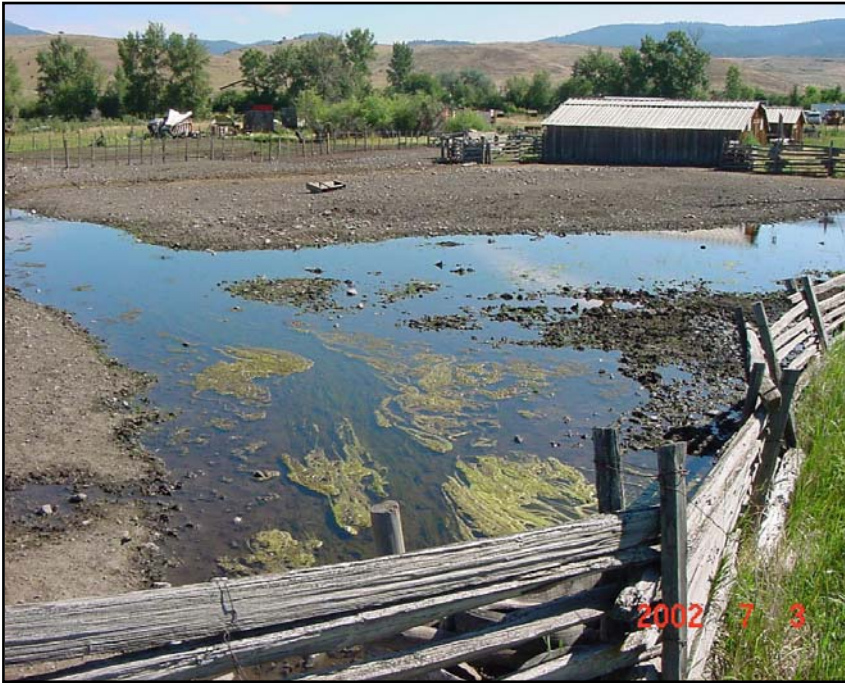
Photo 14. Emmel RFC Project pre-construction.

The Emmel RFC project area is located east of Prairie City within migratory and rearing habitat for spring Chinook and steelhead on the Mainstem John Day River. The Return-flow Cooling project replaced the open ditches with perforated PVC pipe. These pipes collect return flows below ground and transport the run-off to the river directly and reducing fecal contamination from feeding areas into the river.

1. Input and analyze data collected under the 2000 monitoring plan for the project site.
2. Complete the engineering survey and design layout.
3. Install buried perforated PVC pipe to replace existing open irrigation return system.
4. Rebuild fences removed during construction.

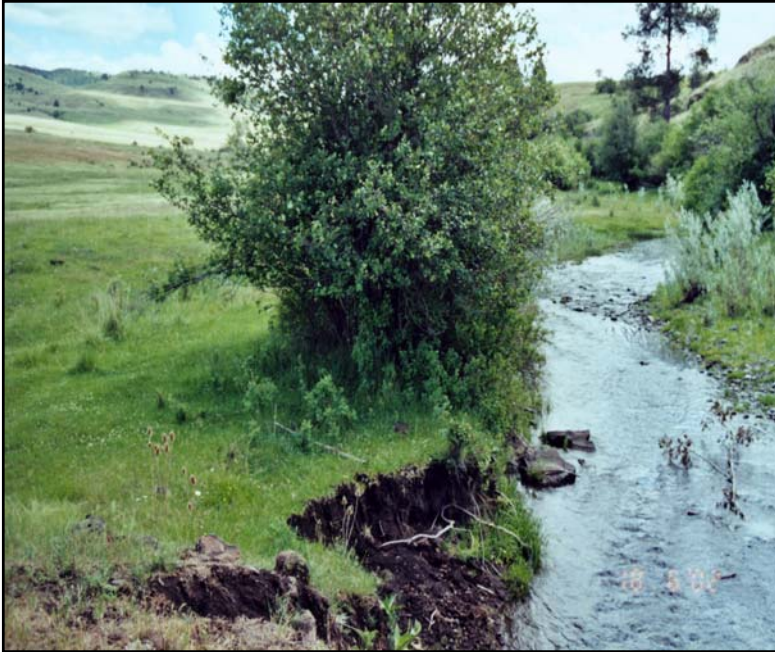
Photo 17. Riparian Corridor on Blackwell property along Long Creek pre-construction.

Project Background; The Henslee Riparian Fencing project incorporates property on three different ranches that is leased by a landowner that has displayed considerable cooperation and interest in restoration efforts. This project fences off sections of Long Creek on two of the ranches, and Shaw Creek on the main landowners ranch. Long Creek has good potential for recruitment of new growth from woody species. This creek runs along a plateau, the side of which creates a natural barrier to cattle access on that side of the creek. Shaw Creek, on the other hand, runs through an open field. The fence here will provide protection from cattle impact, supporting vegetation and channel recovery, and in turn will benefit the rancher by protecting calves from falling in the creek during their first few days. Shaw Creek runs into Paul Creek, which, along with Long Creek, offers habitat for summer steelhead and resident trout. All three creeks are tributaries of the Middle Fork John Day River. **Total miles of habitat protected was 4.5 at the three locations.**
